OFFSHORE CLEANING SYSTEMS THERMOGRAPHIC REPORT

Report Date: 10-10-07

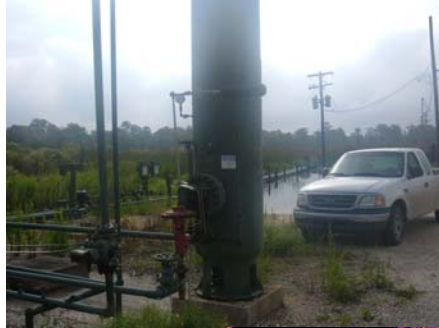
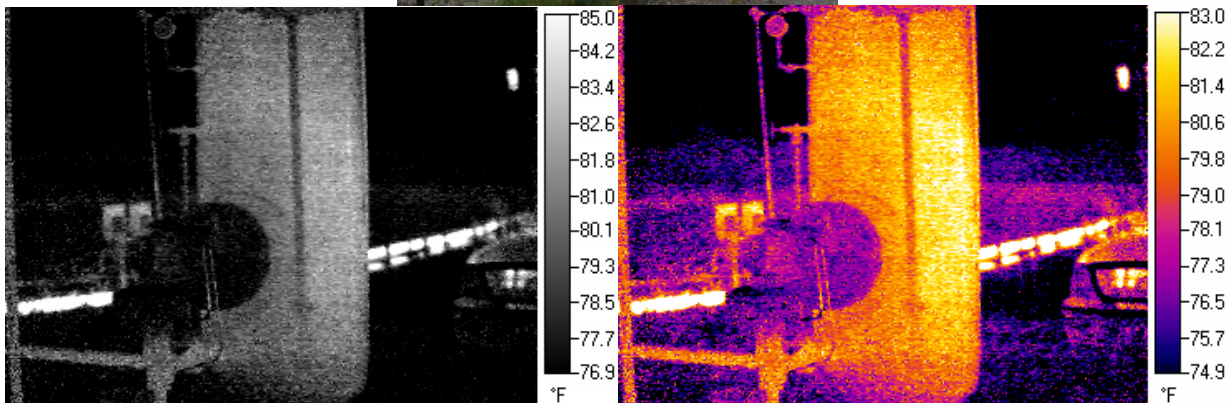
COMPANY:	LOCATION:
CONTACT:	PHONE:
EQUIPMENT ID: V8043 Test Separator	SURVEY DATE: 10-9-07

The Test Separator was a uniform 80-81°F throughout the vessel and no indication of sediment / solid accumulations.

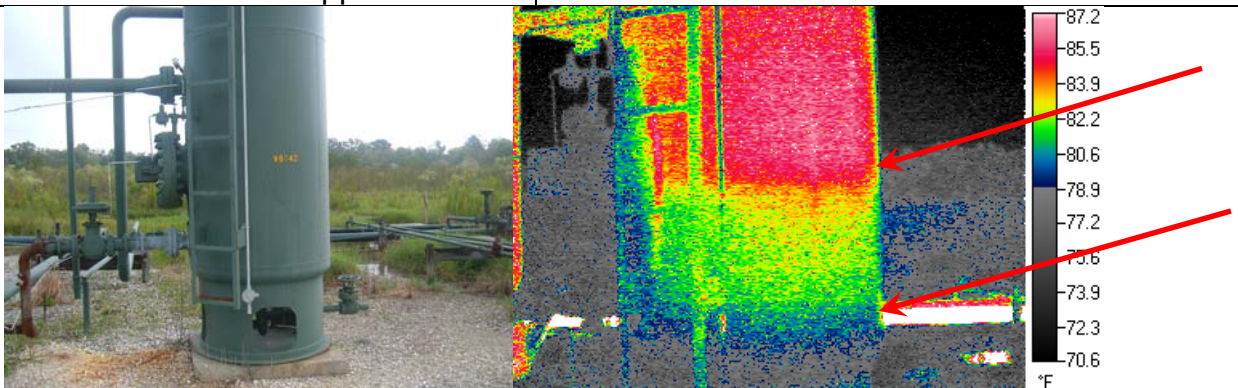
EQUIPMENT ID: V8042 Gas Stripper	SURVEY DATE: 10-9-07
----------------------------------	----------------------

The Gas Stripper had a noted liquid level at approximately 2 feet above the lower seam (upper arrow) on the shell, just below the liquid level controller. There is a 4°F temperature drop in the lower 6 inches below the liquid outlet (lower arrow), indicating sediment.

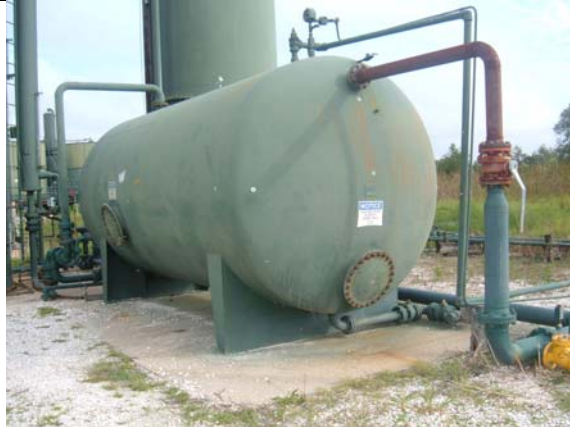
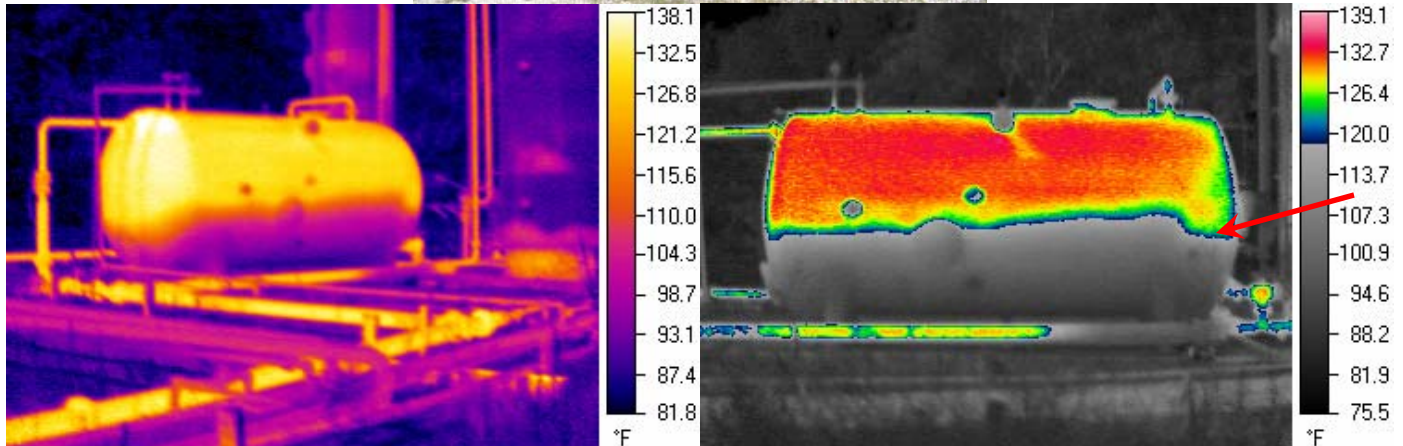
EQUIPMENT ID: V7500 FWKO

The Free Water Knock-out has 3-4' of sediment accumulations through-out the vessel. The red arrow notates a depression near the water outlet.

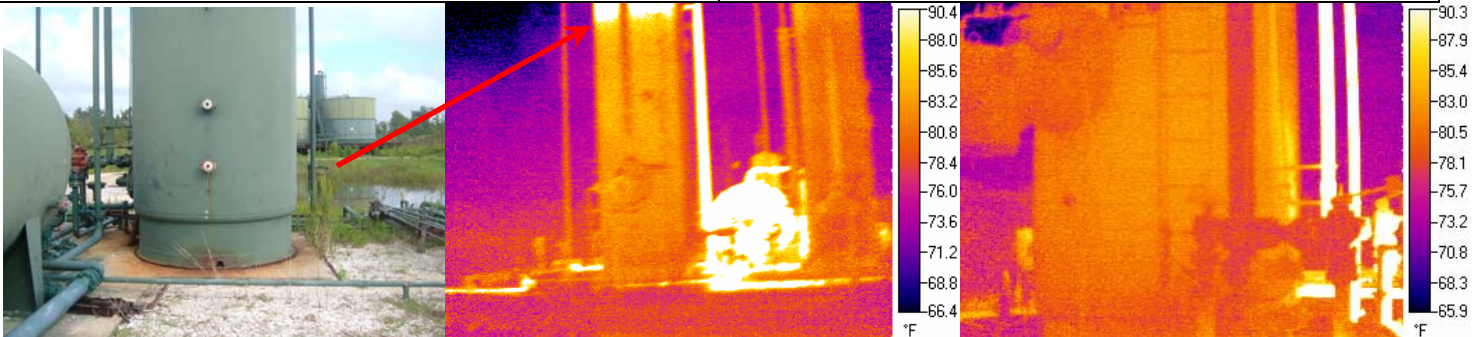
EQUIPMENT ID: V7565 Prod Treater

The Production Treater temperature was consistent throughout the lower part of the vessel. The third photo shows an increase in temperature near the skirt, probably due to ambient warming. No solids noted. Liquid level noted with red arrow.

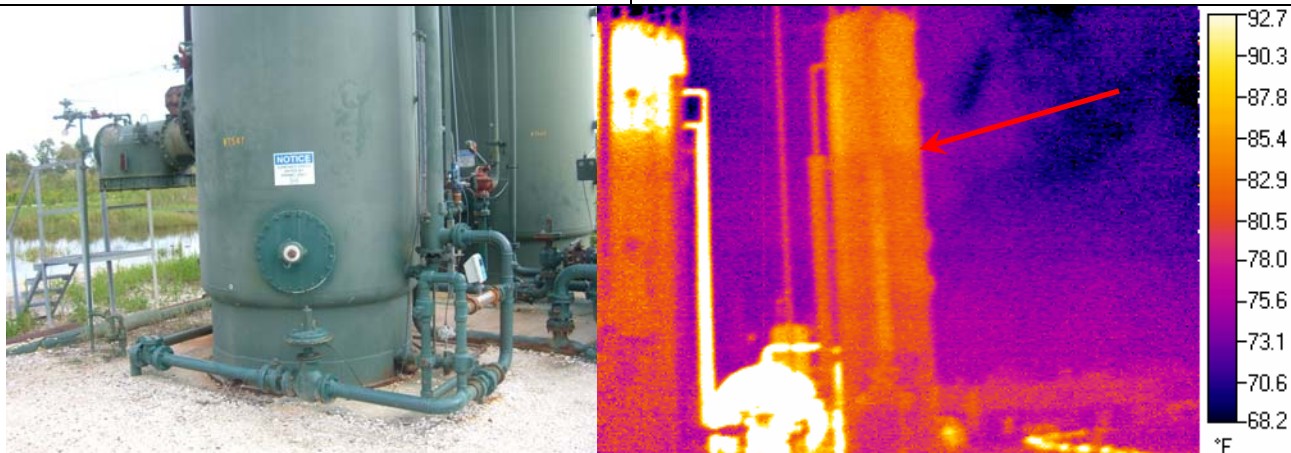
EQUIPMENT ID: V7547 Test Treater

The Test Treater temperature was consistent throughout the entire vessel. No solids noted. Liquid level noted with red arrow.

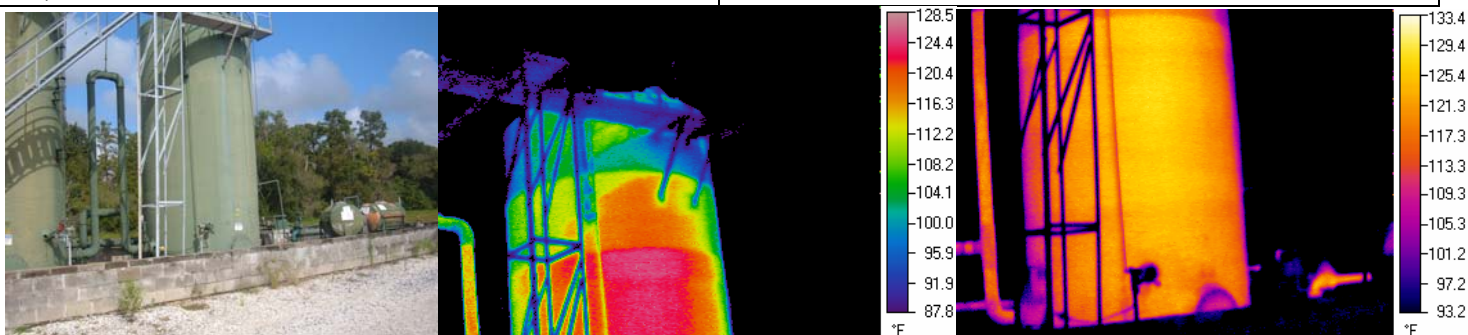
EQUIPMENT ID: T4200 North SW tank

The North Saltwater tank temperature was consistent throughout the lower portion of the tank (right). The upper portion shows the water / oil / void interface (middle). No solids noted.

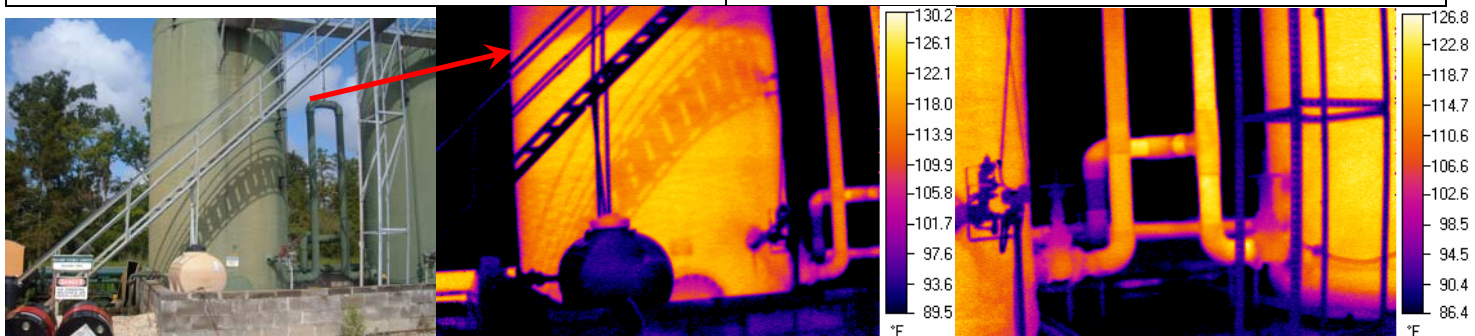
EQUIPMENT ID: T4201 South SW tank

The South Saltwater tank temperature was consistent throughout the lower portion of the tank. Liquid level noted with red arrow. No solids noted. Right photo is detail of equalization line between tanks.

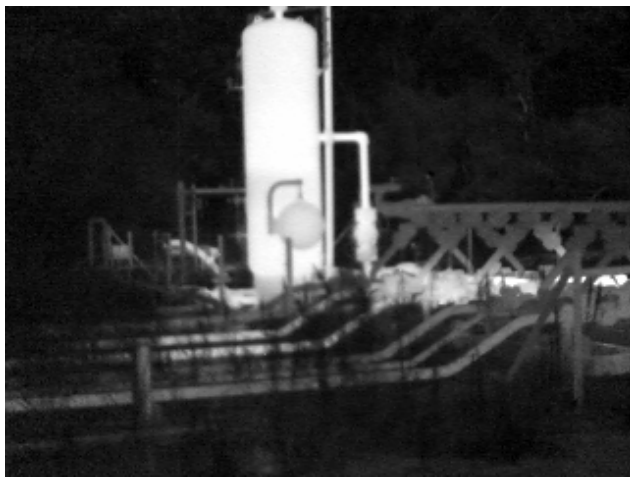
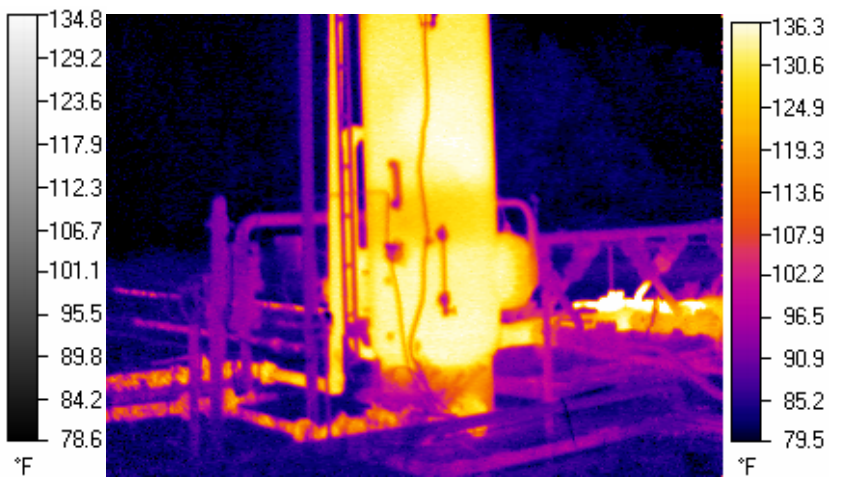
EQUIPMENT ID: V8283 Prod. Fluid Separator SURVEY DATE: 10-9-07

The Production Fluid separator at the header location had consistent temperature throughout the vessel. The liquid outlet was located on the extreme bottom of the lower vessel head, probably allowing produced solids to dump to a downstream location.

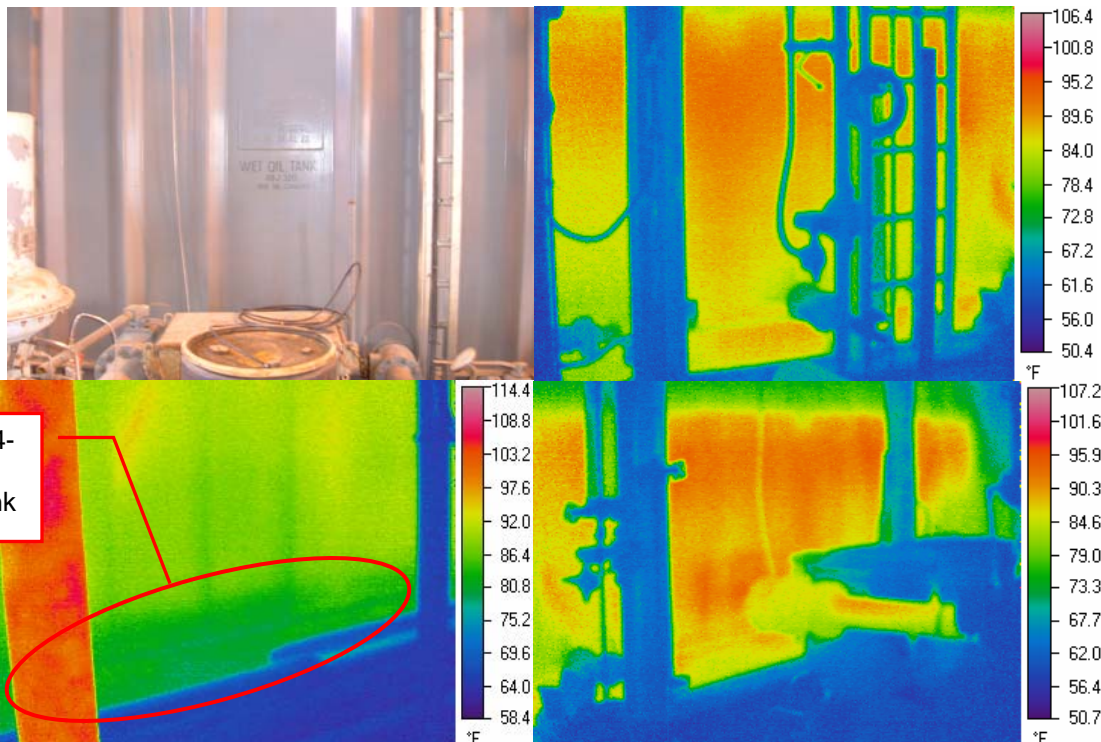
Center of wet oil tank

Sediment 4-6" across base of tank

The Wet Oil Tank appears to have sediment levels 24-30" near the corners and at least 4-6" across the base. Assuming an average level of 18" would equal 144bbls.

If no large piles near the center of the tank are encountered upon entry, (8) 25-bbl cuttings boxes for sand and (3-4) 25bbl boxes for wash water should be sufficient to complete this job. If solids settle well, the majority of wash-water and recovered oil may be able to be sent back to process.

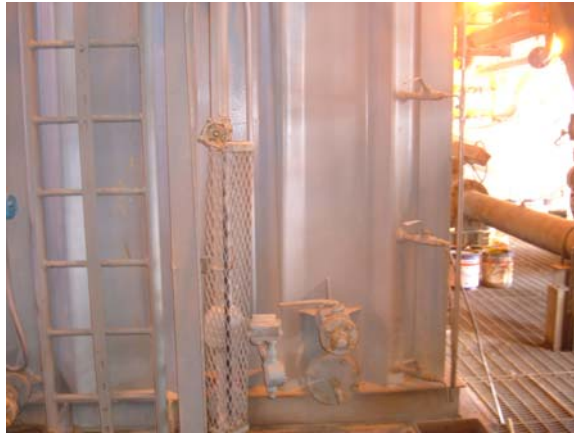
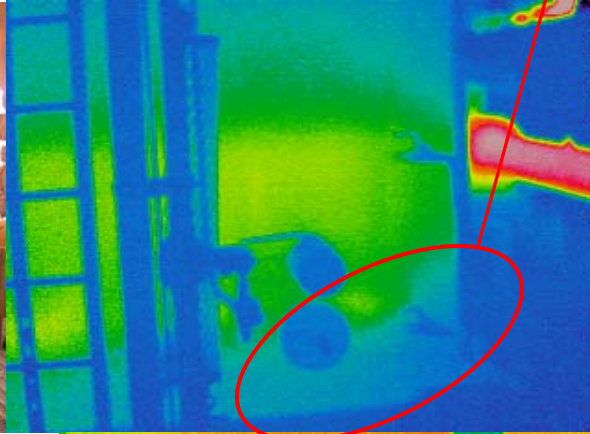
Front bad oil tank

Small sediment pile near corner

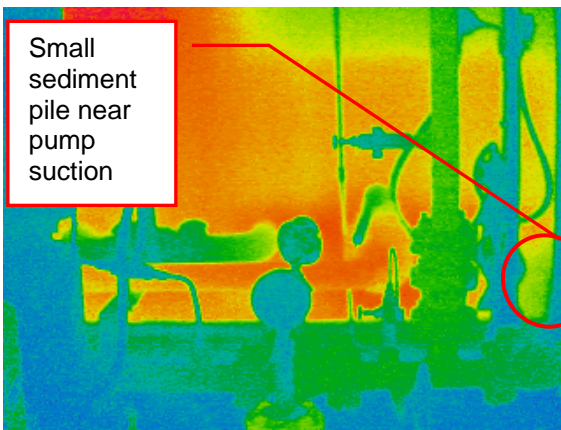
Small sediment pile near pump suction

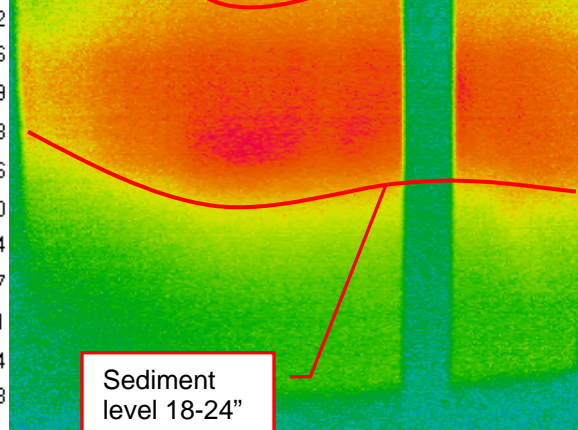
Sediment level 18-24" across base of tank

The Bad Oil Tank appears to have sediment of approximately 18-24" across most of the tank equating to 49-65 bbls.
